# Release Notes

## OmniAccess Stellar AP

### AWOS Release 5.0.3 GA - Release

These release notes accompany the OmniAccess Stellar Operating System (AWOS) Release 5.0.3GA software for the Stellar APs. This document provides important information on individual software and hardware features. Since much of the information in the release notes is not included in the hardware and software user manuals, it is important to read all sections of this document before installing new hardware or loading new software.

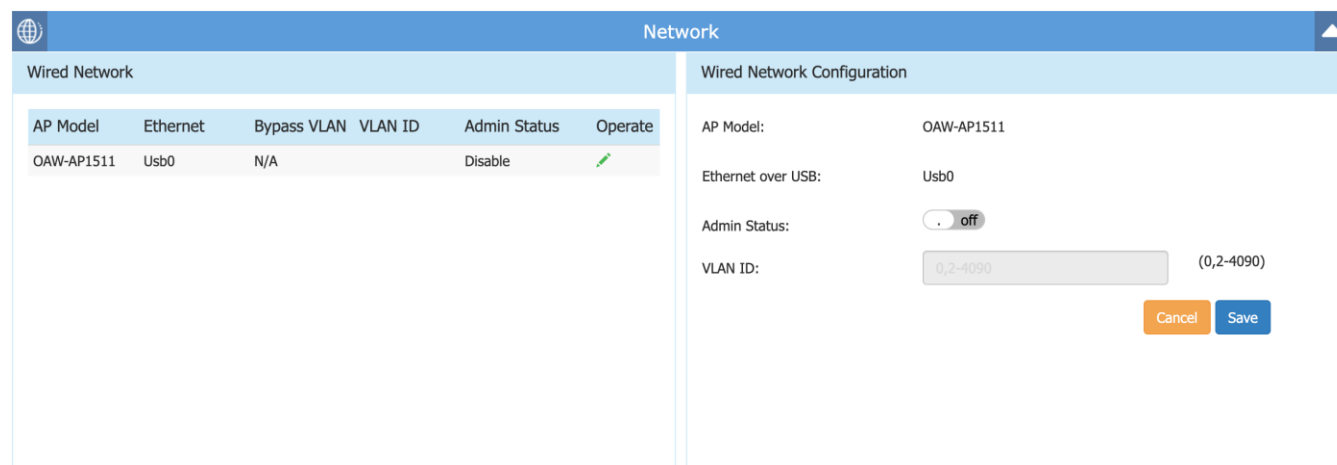
Express

Below is the configuration display:

| AP Model | Ethernet | Bypass VLAN | VLAN ID | Admin Status | Operate |
| OAW-AP1511 | Usb0 | N/A | | Disable | |

**Wired Network Configuration**

VLAN ID:  (0,2-4090)

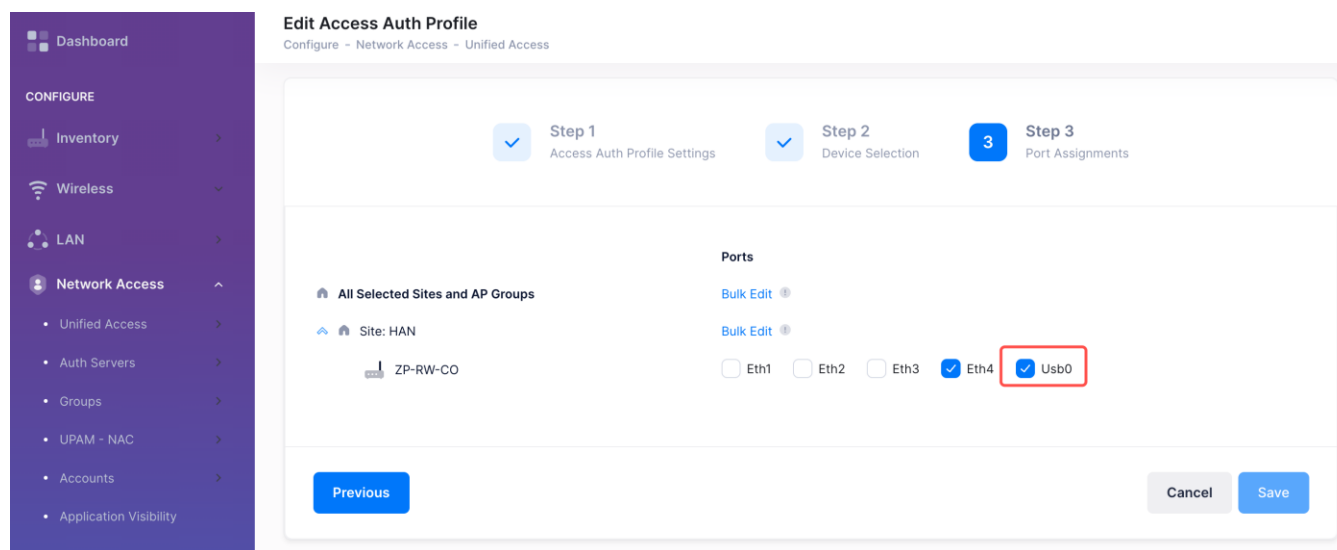
OmniVista Cirrus 10

**Edit Access Auth Profile**  
Configure - Network Access - Unified Access

Step 1: Access Auth Profile Settings | Step 2: Device Selection | **Step 3: Port Assignments**

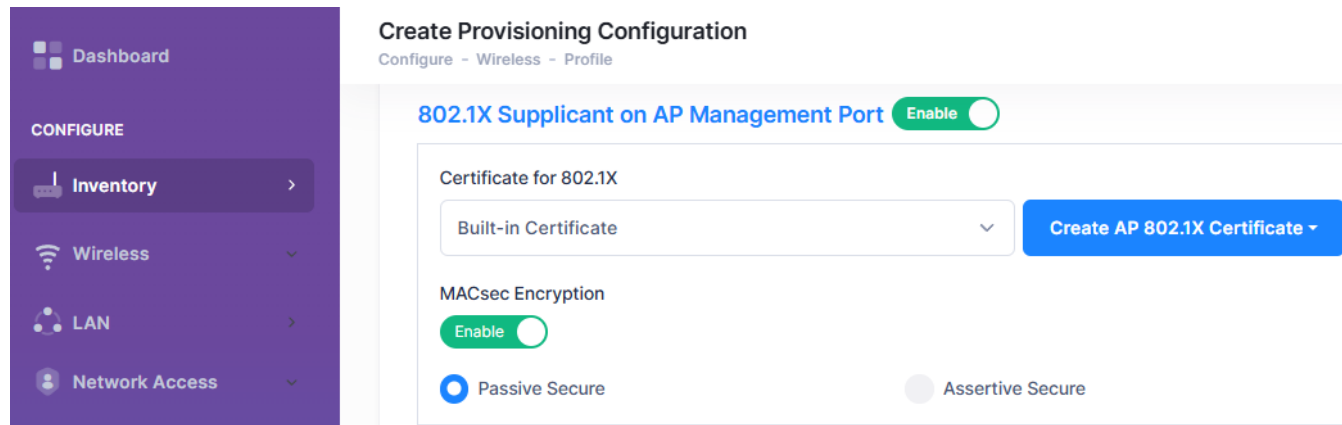
Assertive Secure: MACsec encrypted, else remains block.

Below is the configuration display:
